MAINTENANCE 143

External shift mechanism inspection

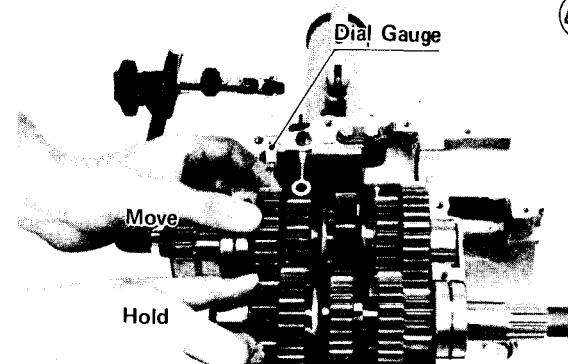
measure the backlash, set a dial gauge against the teeth on one gear, and move the gear back and forth while holding the other gear steady. The difference between the highest and the lowest gauge reading is the amount of backlash. Replace both gears if the amount of backlash exceeds the service limit.

Table 68 Gear Backlash

Standard	Service Limit
under 0.17 mm	0.25 mm

Gear backlash

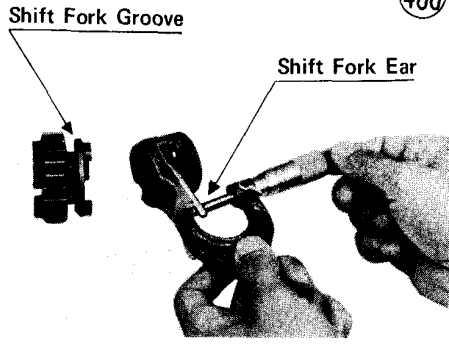
Shift fork/gear groove wear

Measure the thickness of the ears of each shift fork, and measure the width of the shift fork grooves on gears D3, 04, and 05. If the thickness of a shift fork ear is under the service limit, the shift fork must be replaced. If a gear shift fork groove is worn over the service limit, the gear must be replaced.

Standard	Service Limit
4.9~5.0 mm	4.7 mm

Table 69 Shift Fork Thickness

Standard	Service Limit
5.05~5.15mm	5.25 mm

Table 70 Gear Shift Fork Groove Width
